PROPER APPLICATION & MAINTENANCE OF MOLDED CASE BREAKERS TO ASSURE SAFE AND RELIABLE OPERATION

Mark Higginson
Senior Member, IEEE
Electrical Maintenance Manager
North Pacific Paper Corporation
PO Box 2069
Longview, WA 98632
USA

David B. Durocher
Senior Member, IEEE
Industry Manager
Eaton Corporation
26850 SW Kinsman Road
Wilsonville, OR 97070
USA

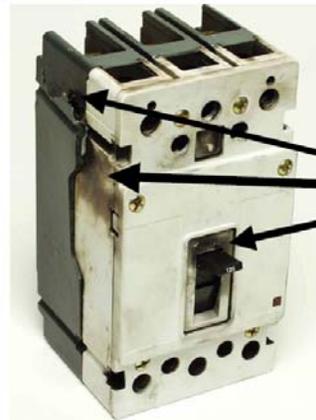
If a circuit breaker with a cracked case or burn marks is found, take the circuit breaker out of service and replace it as soon as safely possible

Fig. 4: Photo from IEEE Standard 1458 showing visible external damage to a breaker case, a stated reason to remove the breaker from service.

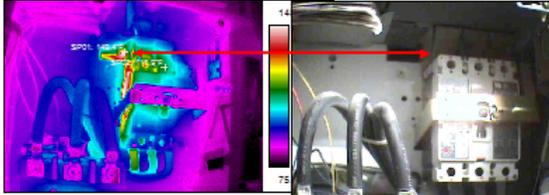
Fig. 7: Infrared inspection of 150 ampere Breaker 4919-2 located in LV MCC D304D-3C.

1) *Test Case 1:* The first breaker to be reviewed is a 150 ampere magnetic-only MCCB located in MCC designation D304D-3C. This breaker is identified as Breaker ID 4919-2 (see Appendix A). The MCCB was originally manufactured in 1995, so it had been in service for nearly 13 years. Fig. 7 shows the results from IR scans conducted at the mill site in January 2008. Thermal inspection for this breaker suggested a hot spot temperature of 149.4°F, a temperature above the 130°F threshold temperature identified in the IEEE 1458 Standard (as discussed previously in Section III.C of this text). Note from this thermal image that the observed elevated temperatures resided near the line terminals at the top of the breaker and down the left side. The line terminal connections were checked for tightness, but the temperature issue persisted. Although it was difficult to determine the source of elevated temperatures for the image, with known good terminations the test technician elected to remove this breaker from service and replace it during a scheduled outage.

HOT SPOT	149.4°F
REFERENCE TEMP.	117.9°F
DELTA-T	31.5
MAX RATED AMP LOAD	
ACTUAL AMP LOAD	
COMMENTS	CHECK CONNECTION A-PHASE TOP OF BREAKER
REPAIR / DATE	
REPAIRED BY	
COMMENTS

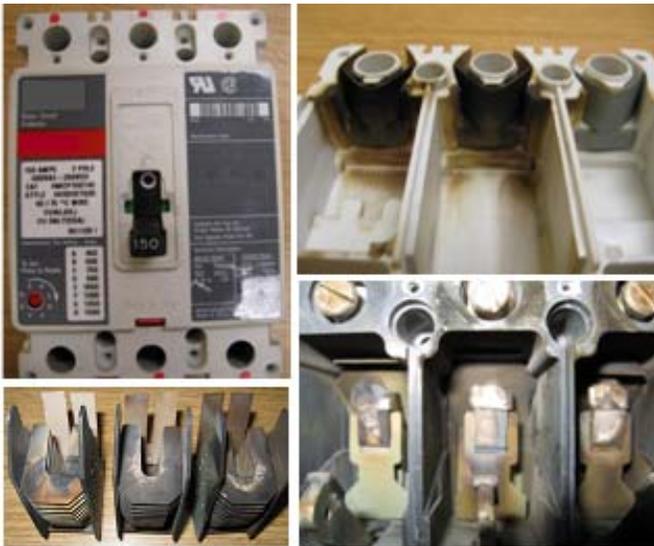
This breaker was then returned to the manufacturer's PIC for analysis. At the PIC, the breaker cover was removed, and each arc-chute assembly was removed from the molded casing. Photos of the breaker external case as well as the inside of the breaker cover, contact area and arc-chute components were taken as shown in Fig. 8. Although there was no visible external damage, some internal components appeared visibly discolored. This evidence suggests that this breaker had interrupted multiple fault currents of a fairly high magnitude. The mill recorded IR thermal hot spot at the upper section of the breaker. This may be significant in that this is in proximity of the MCCB main contacts, suggesting a higher contact resistance, perhaps caused by erosion of the contact surface following interruption of a high-level fault.

Fig. 8: Photos of Breaker 4919-2 clockwise from upper right; external breaker case, line-side of breaker cover, main moving and stationary contacts, arc-chute assemblies.

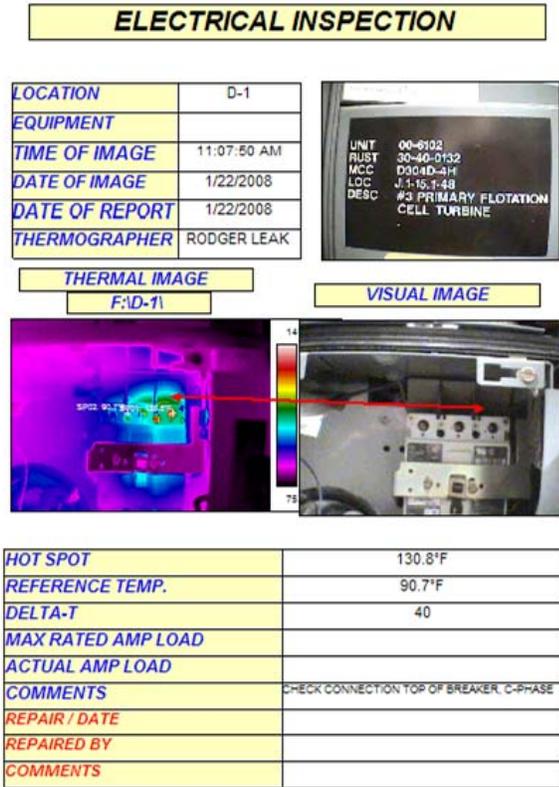
2) *Test Case 2:* The second breaker to be reviewed was also a 150 ampere magnetic-only MCCB located in low-voltage MCC designated D304D-4H. This breaker is identified as Breaker ID 4919-4 with PIC recorded test data shown in Appendix A. Fig. 9 shows the results from IR scans conducted at the mill site in January 2008. Thermal inspection of this breaker suggested a hot spot temperature of 130.8°F. This temperature is just above the 130°F threshold identified in the IEEE 1458 Standard. Once again, from the thermal image the thermal hot spot temperatures appear to be at or near the line terminals of the MCCB. After cable terminations were checked for tightness, this breaker was also removed from service during a rotational outage, again suspected of possible internal damage. This breaker was returned to the manufacturer's PIC, then disassembled and photographs were again taken as shown in Fig. 10. In contrast to the photos for breaker 4919-2 shown in Fig. 8, the photos of this breaker appear to show very little visible wear or burning, evidence of interruption of higher-level faults. The contact surfaces appear only slightly discolored, particularly for phase B and C poles. The arc-chute assemblies look nearly new, although once again, this breaker had a service life of nearly 13 years, with a manufacturing date of November 1995.

The PIC lab thermal test stabilized in 3 hours, 10 minutes when the test was considered complete. Table III shows results from this test. In this case, five out of six of these tested values highlighted in Table III exceed the thermal design threshold of 50°C, with line terminals B and C

demonstrating the highest measured temperatures, a result verified by field based IR scans. Overall, the lab test once again delivered results consistent with IR scans from the field.

Fig. 9: Infrared inspection of 150 ampere Breaker 4919-4 located in LV MCC D304D-4H. Note elevated temperature at line side of MCCB poles B and C.

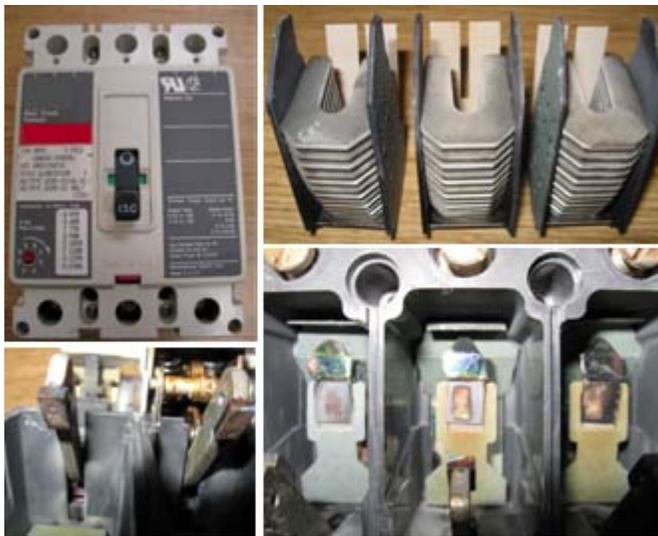
Interestingly, there was a significant disparity between phase terminal temperatures, but with less visible discoloration from the photographs in Fig. 10.

Fig. 10: Photos of Breaker 4919-4 clockwise from upper right; external breaker case, arc-chute assemblies, main moving and stationary contacts with evidence of elevated heat primarily on Phases B and C, close-up of Phase C moving contact.

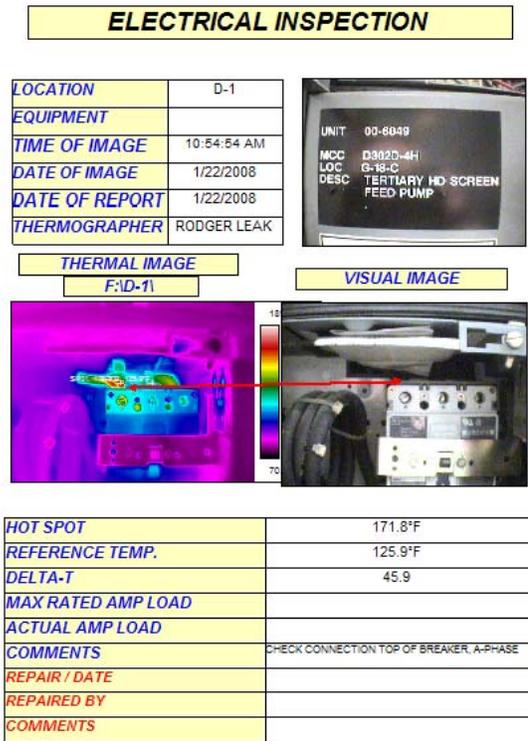
3) Test Case 3: The third breaker to be reviewed is also a 150 ampere magnetic-only MCCB; this one located in low-voltage MCC designated D302D-4H. This breaker is identified as Breaker ID 4919-1 with PIC recorded test data shown in Appendix A. Fig. 11 shows the results from IR scans conducted at the mill site in January 2008. Thermal inspection for this breaker suggested a hot spot temperature of 171.8°F. This temperature is well above the 130°F IEEE 1458 Standard threshold. Once again, from the thermal image the hot spot temperatures appear to be at or near the line terminals of the MCCB. After cable terminations were checked for tightness, this breaker was also removed from service during a rotational outage.

Fig. 11: Infrared inspection of 150 ampere Breaker 4919-1 located in LV MCC D302D-4H. Note elevated temperature at line side of MCCB with hot spot temperature of 171.8°F.

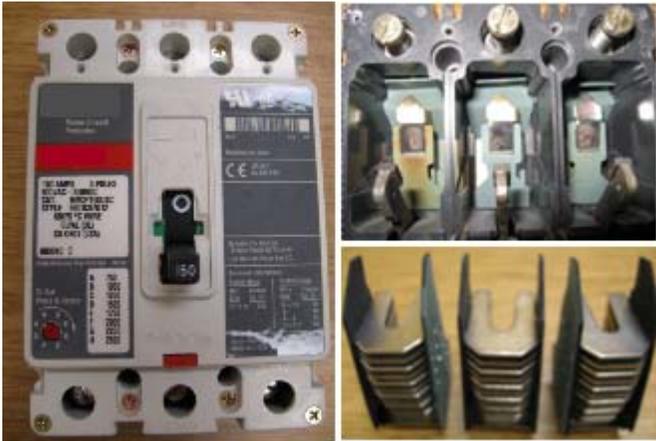
This breaker was also returned to the manufacturer's PIC where it was disassembled. Photographs are shown in Fig. 12. Similar to the previous example of Breaker 4919-4, the internal components of this MCCB appear to show very little visible wear or burning. The contact surfaces appear only slightly discolored, particularly for the Phase A breaker pole. This breaker was manufactured in December 1999, so the MCCB was in service for just over 8 years.

Fig. 12: Photos of Breaker 4919-1 clockwise from upper right; external breaker case, main moving and stationary contacts, arc-chute assemblies.

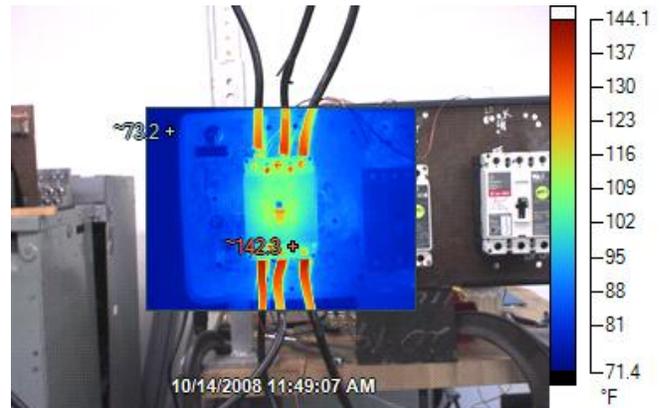
It's instructional here to note that the thermal test lab at the PIC also included a thermal image test using thermography similar to the field based IR scans. Fig. 13 shows the test lab thermal image for Breaker 4919-1. Comparing this image to the field IR scan shown in Fig. 11, the hot spot temperature was recorded at 142.3°F, a value much lower than the 171.8°F hot spot temperature measured by the mill. This suggests that perhaps some variable in the field such as an unbalanced load or a line terminal that in fact was improperly tightened, caused an overall higher hot spot temperature. It is also interesting to compare the field and test lab overall thermal images of this breaker. Note that the thermal profile of the lab test appears more consistent throughout the MCCB

frame, whereas the field IR scan shows a more isolated area of elevated temperature. Remember that the IR camera is recording surface temperature. IR is not measuring the actual heat generated by the conducting components of the breaker, but instead the camera measures the deflected and absorbed temperature of the conductors through the breaker frame. The lab test condition represents a balanced 3-phase 150 ampere current, while the field test condition presents infinitely more variables. So, some variability is to be expected.

Fig. 13: PIC thermal scan of breaker 4919-1. Breaker tested at 150 ampere rated load for 4 hours, 35 minutes, 142.3°F hot spot.

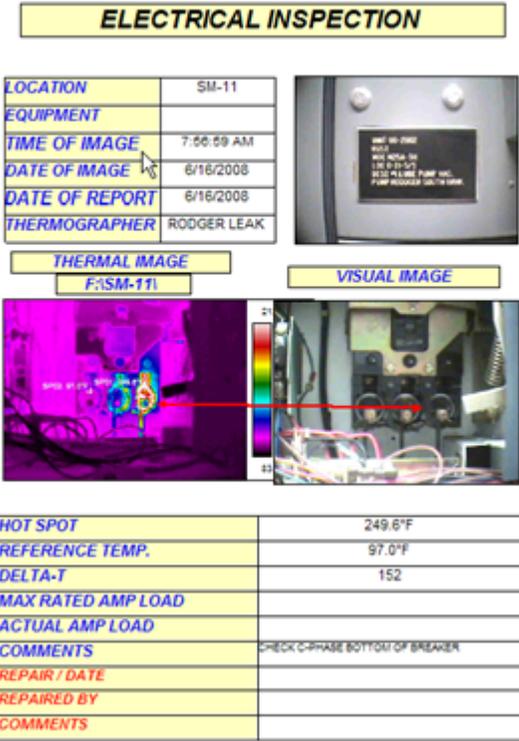
The current limiter looks to be another good candidate for routine IR surveys as a means to attempt to determine when an overcurrent protective device may not be capable of interruption as designed, and therefore should be removed from service and replaced.

Fig. 14: Thermal scan of partially failed current-limiter installed in Paper machine #1 area. Elevated hot spot temperatures of nearly 250°F resulted in a decision to remove this device from service.

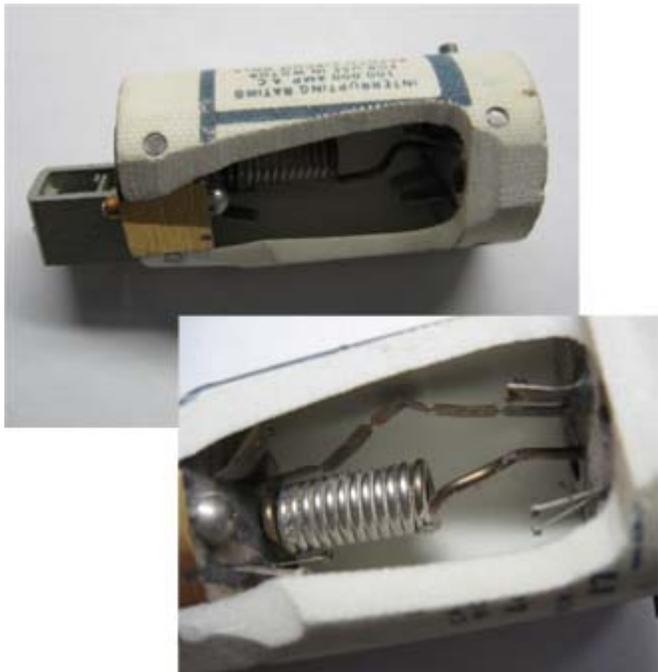
Fig. 15: Photo of current-limiter removed from service from Paper Machine #1 area. Cutaway view shows three elements melted while one remains intact.
